**VR14 and VR20
troubleshooting
procedures**

1st Printing June 1972

1. INTRODUCTION

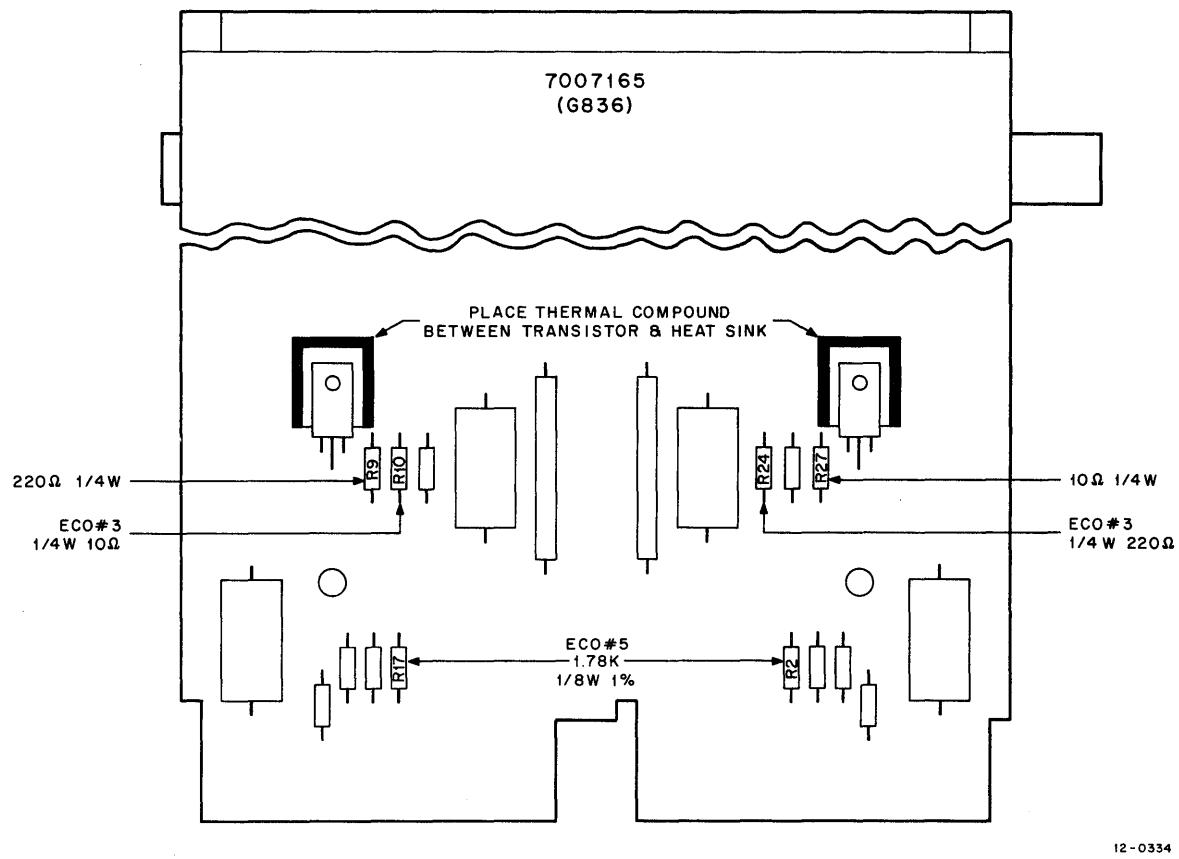
Figure 1 7007165 Power Regulator Assembly

4	<p>Check the G836 regulator card on the 7007165 to ensure all ECOs have been incorporated (see Figure 1).</p> <ol style="list-style-type: none">R9 and R24 should be 220 ohms, <i>not</i> 1K.R10 and R27 should be 10 ohms, <i>not</i> 150 ohms.R2 and R17 should be 1.78K, 1% resistors, <i>not</i> 1.62K, 1%. This lowers the $\pm 24V$ to $\pm 22V$. <p>If power supply voltages drift or wander, change Q2 (2N4920), Q4 (2N4923), E1 (709), and E2 (709) or obtain a new 7007165 regulator. Make certain that the board (G836) in the new regulator is <i>revision D</i> or higher. Reworked revision B boards with a decal are acceptable.</p>
5	<p>Make certain that the A225 boards have ECOs 2, 4, 5, and 6 incorporated (Figure 2).</p> <p>ECO #2 R29 and R30 (22 ohms) replaced by wires. ECO #4 R1 and R2 are 10K 1/4W. ECO #5 C12 is 100 pf. ECO #6 R19 is 200 ohms 1W.</p>
6	<p>In order to increase heat dissipation for the power transistors, ECO #VR14-15 must be installed. This ECO consists of physically interchanging the inside section (X) of the deflection heat sink assembly with the outside section (Y). This is done because the outside section receives better air flow. Since X generates more heat than Y, X requires more cooling air.</p>

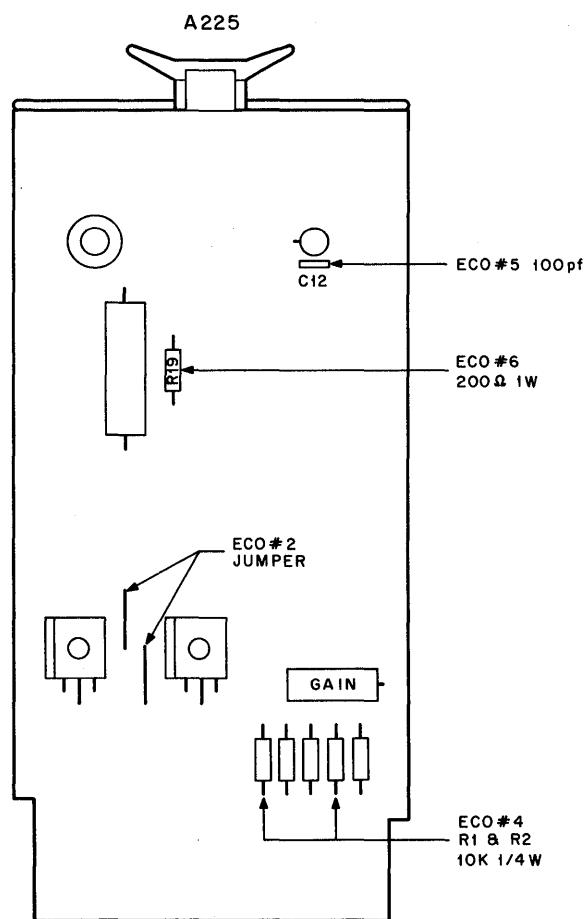
Figure 2 A225 D/A Converter

Step	Procedure
1	Replace the fuse and obtain a picture on the display.
2	Remove the top screen on the VR14 and, while a picture is displayed, shake and wiggle the four cables and associated connectors coming into the G836 regulator. If the picture breaks up under this condition, it indicates a faulty pin or connection that must be repaired. If a bad connection interrupts a critical voltage, the deflection amplifier deflects the beam off screen and blows the fuse.
3	If shaking fails to isolate the problem, then one of two problems exists: <ol style="list-style-type: none">The <i>input</i> deflection signals are intermittently excessive, thereby driving the CRT beam off screen and blowing the fuse.A power latch-up problem exists.
4	Check the computer D/A converters for intermittent or incorrect outputs. Make certain that there are no oscillations on the D/As.
5	Check for a power latch-up problem. When power is turned on, the deflection amplifier settles to its normal operating conditions. However, if power is subsequently turned off and immediately turned on again (within 1/2 second), the deflection amplifier may receive the power supply voltages in such a manner that the deflection amplifier saturates driving the CRT beam off screen. The deflection amplifier is then prevented from recovering unless powered down for one second or longer. If a power latch-up problem occurs, it is worse at low line (<110 Vac). If the VR14 is left on in this latch-up mode, the deflection amplifier saturates and blows the -22V, 10A fuse. However, no other harm is done. Make certain that resistor R19 on the A225 is 200 ohms rather than 270 ohms (see Figure 2). The resistor was changed by ECO #A225-6 to prevent a latch-up problem.

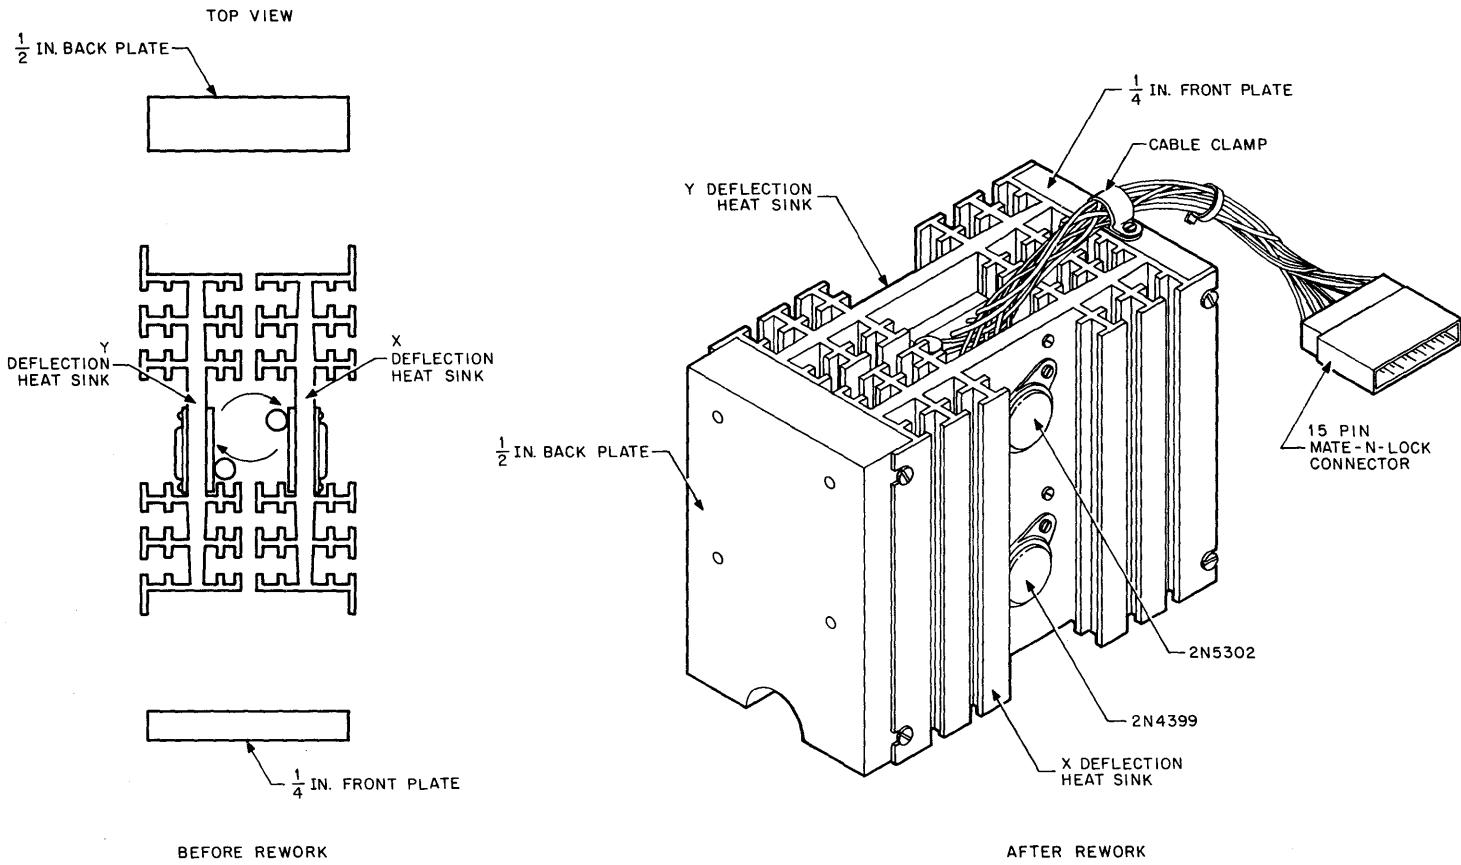
Figure 3 Deflection Heat Sink

The deflection heat sink can be reworked to provide better heat dissipation for the power transistors as described in Step 6 of Procedure A (Parargaph 2). The X heat sink, which generates more heat than the Y heat sink, is physically exchanged with the Y heat sink with the result that the X heat sink is near the outside of the VR14 chassis. In this position it gets better air circulation for cooling. The following procedure provides the method of reworking the heat sink assembly (see Figure 3).

Step	Procedure
1	Remove deflection heat sink assembly from the VR14.
2	Remove 6-32 X 3/8 screw that secures cable clamp to 1/4-inch front plate.
3	Remove eight 6-32 X 1/4 screws that secure X and Y heat sinks to front and back plates.
4	Remove thermal cutout from X deflection heat sink and place a 6-32 X 1/2 pan head screw in the hole.
5	Place 1/2-inch back plate on a flat surface with the two mounting screws (used for securing heat sink) facing up and half-circle cutout facing the bottom.
6	Secure the X deflection heat sink (identified by grey wire on transistor collectors) to the 1/2-inch back plate, using two 6-32 X 1/4 screws. Make certain the 2N4399 transistor is on the bottom.
7	Place 1/4-inch mounting block on other side of the X deflection heat sink with the cable clamp screw hole facing the top. Secure with two 6-32 X 1/4 screws.
8	Secure the Y deflection heat sink (identified by violet wire on transistor collectors) to the opposite side of the assembly, ensuring that the 2N4399 is on the bottom.

9	Secure the cables from X and Y deflection heat sinks to the top of the 1/4-inch front plate with cable clamp and 6-32 X 3/8 screw.
10	To complete the AC line circuit, place a jumper plug (7007006-3) in the 2-pin connector that was connected to the plug for the thermal cutout.
11	Replace deflection heat sink assembly in the VR14.
